“CLEAN BURN” FIRE PATTERNS – A NEW PERSPECTIVE FOR INTERPRETATION

Steven W. Carman, IAAI-CFI, ATF-CFI (Retired)
Carman & Associates Fire Investigations, Dunsmuir, CA

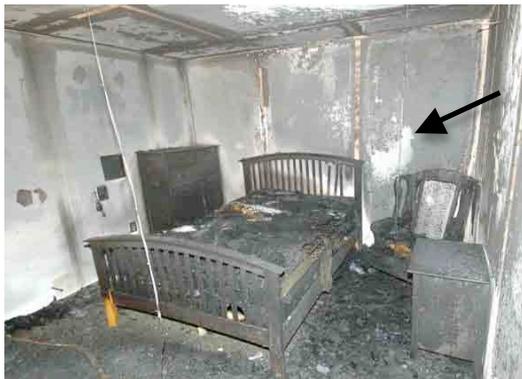
Fig 2 - Cell 1 showing clean burn

After the FRL tests were completed, burn damage was documented and examined. After the first test fire (Cell 1), an area of clean burn was observed on the wall near the area of origin (left wall facing the door from outside). Approximately 45 inches above the floor was an irregularly shaped clean burn pattern that measured about 20 inches wide and 12 inches high. This area was contiguous to and above the top of the plastic trashcan that had been between the bed and upholstered chair. Arrows in Figures 2 and 3 point to the pattern.

Such wall heating prior to soot adsorption may have been responsible for causing the clean burn pattern near the area of origin in Test 1. Early on in the fire, flames from the trashcan impacted a relatively small area of the left wall causing a likely steep temperature gradient in the gypsum wallboard. The resulting thermophoresis would have tended to repel soot particles from the hotter surface.

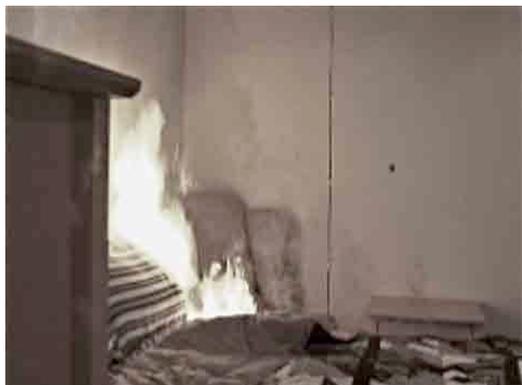
Fig 4 – Test 1 at 28 seconds after ignition (video shot through exterior viewing port)

Examination of interior and exterior video revealed this pattern was consistent with an area of early flame contact with the wall. Figures 4 and 5 are still-photos captured from video 28 seconds after ignition in Test 1. In the video, no noticeable smoke or soot deposits are seen on the wall adjacent to the flames.

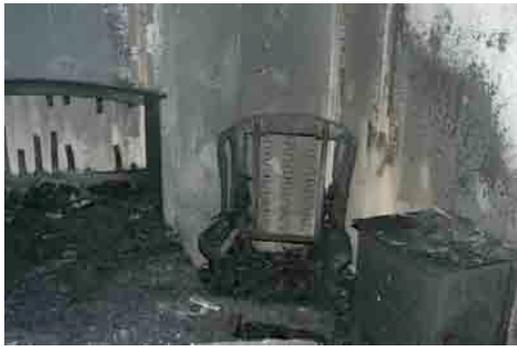
Fig 6 - Wall behind origin, Cell 2

The three cells were examined in the order they were burned. Since each of the fires was started in the same fashion, investigators expected to find similar fire patterns near the origins. It was thought that the extent of damage might differ due to longer burn times in Tests 2 and 3. The findings were surprising. Neither Cells 2 nor 3 had any clean burn patterns near the origin as seen in Figures 6 and 7. This was despite video showing similar early flame contact with the nearby walls in each of those tests like occurred in Test 1. Photos of the flames impacting the walls are shown in Figures 8 through 11.

Although there was no similar clean burn areas on the left-side walls of Cells 2 or 3, depth-of-calcination measurements taken in all three cells near the origin showed similar, localized damage in the same general areas. In each case, areas of deeper calcination were generally consistent with the location of initial flame impact seen in the videos. In Cells 2 and 3, calcination damage was somewhat more severe than in Cell 1, possibly due to the longer burning times of the adjacent chairs. Damage on the wall between the chair and the bed was greatest from about 2 to 4 feet off the floor and then lessened moving further upwards.

In Tests 2 and 3, the fires burned under ventilation-controlled conditions about two minutes longer than happened in Test 1. In that extra time, temperatures throughout the hot gas layer remained high causing the walls to heat more evenly. Even-heating would tend to dissipate thermal gradients across the wall faces. With lower gradients, soot would not tend to be repelled from localized areas. Also, the extra two minutes of ventilation-controlled burning in Tests 2 and 3 would have fostered higher soot production than in Test 1 (which mostly burned in the fuel-controlled stage).

More even, longer-term wall heating in Tests 2 and 3 (and presumably lower thermophoretic forces away from them) coupled with a higher concentration of soot in the room likely enabled formation of a soot layer over any clean-burn areas that may have begun to form near the origin as in Test 1. While the possible interim creation of such clean-burn patterns in Tests 2 and 3 cannot be confirmed, similar, localized calcination damage was found after all three tests. This suggests the early conditions in each fire may have been similar and conducive to forming comparable clean-burn patterns.

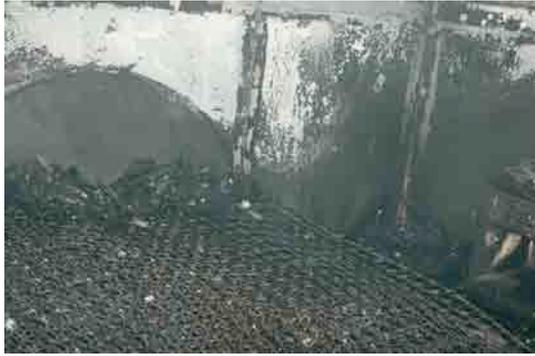
Fig 12 - Las Vegas clean burn

Figure 12 shows a clean burn pattern found near the fire origin in one of the Las Vegas fire tests. That fire burned for 3-1/2 minutes post-flashover. Some might argue this shows that extended burning will not eliminate clean burn patterns since the Las Vegas fire burned longer than either FRL Test 2 or 3. A major difference in the tests is that in the Las Vegas, there was less soot-producing fuel near the clean burn pattern. The wicker chair used in Las Vegas had a small, upholstered cushion shown in Figure 13. In each of the FRL tests, the wicker chair was replaced with a larger, upholstered chair. Those chairs had much more polyurethane foam that would have continued to pyrolyze and release soot into the room after the wicker chair would have mostly burned away. This extra foam could have produced the nearby soot layer coating the wall adjacent to the fires’ origins.

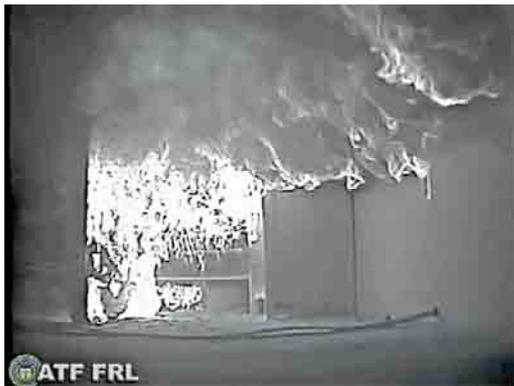
Fig 14 - Test 2 at 3 min 54 sec

There were also other large clean burn patterns in each of the three FRL cells. Two of the patterns, one each in Cell 2 and Cell 3 were amazingly similar in size and location. The onset of the damage in those patterns was recorded on video. Burning of already-deposited soot did not seem to occur. Videos shot from the right wall towards the origin clearly showed flames on the rear wall (opposite the door) appearing to originate in the hot gas layer. At the time, the rear wall near where the flames were burning appeared mostly soot-free.

The white, V-shaped areas across the rear walls of Cells 2 and 3 (Figures 15 and 17) were adjacent to the flames visible at the right of Figures 14 and 16. While the resulting fire damage was severe, it was unrelated to the location of the fires' origins. Ventilation-fed flames in the hot gas layer caused the damage. Depth-of-calcination measurements in the clean burned areas were the deepest in the cells. While some might interpret the patterns as typical V-patterns created by upward plume movement, this was not the case. The burning away of soot deposits off the wall also did not appear to be involved. Instead, likely high thermal gradients on the walls (caused by flame impingement) may have resisted soot from ever being deposited there.

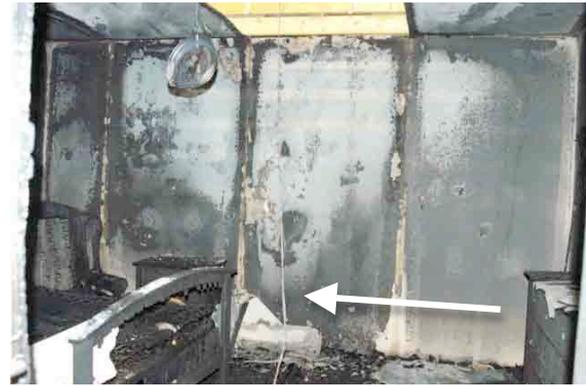
Fig 15 - Test 2 rear wall (arrow shows the orientation of video images in Figs 14 and 16)

A significant finding in these tests was that the rear-wall clean burn patterns were not caused by fuels burning at their bases. Though appearing similar to V-patterns, plumes rising from the bottom of the Vs and intersecting the walls did not cause them. Instead, hot clouds of fuel-rich gases originating elsewhere in the cells had actually created the V shapes by burning from the top downward.
