# **PROGRESSIVE BURN PATTERN DEVELOPMENT IN POST-FLASHOVER FIRES**

Steven W. Carman, IAAI-CFI, ATF-CFI (Retired)  
Carman & Associates Fire Investigations, Dunsmuir, CA

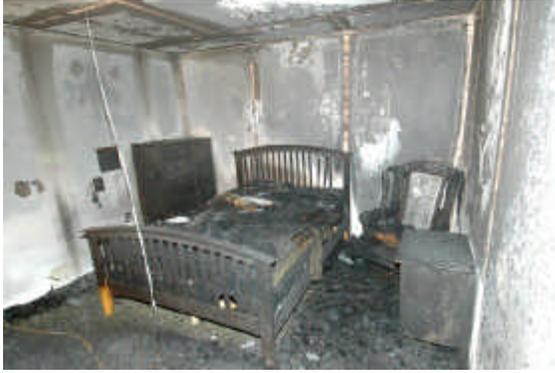
In cell 1, burn patterns alone indicated the room had been close to flashover. Because the bottom of some furnishings had not burned, without witness statements indicating steady flame extension, an investigator may have concluded flashover had not occurred. An area of fire origin was identified near the trashcan between the bed and upholstered chair. A "V-pattern" was obvious amidst the vertical slats of the headboard showing flames or hot gases rising up from between the bed and the chair. Also, an off-white 'clean burn' pattern was clearly visible on the south wall where flames initially contacted it. The irregular pattern measured about 18 inches across and was located between the top of the headboard and the top of the wingback chair. It was similar to the plume pattern in the first 2005 test fire created by the originating fire.

Figure 2. View to S in cell 1 showing clean burn on wall near origin

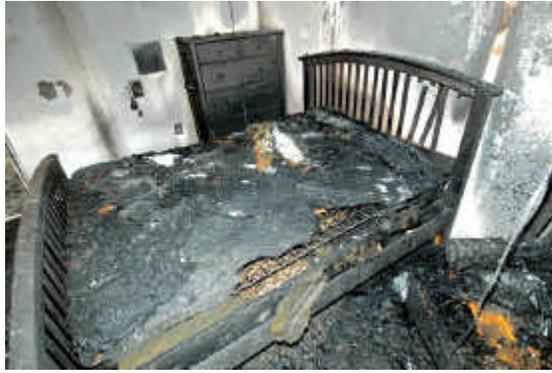
Figure 3. View to SE in cell 1. Localized damage to mattress and frame is evident

Clear delineation of burn damage to the mattress fabric was visible suggesting a heat source between the bed and chair. A plume-impact, clean-burn pattern was on the ceiling generally above the trashcan and chair. Uneven burn damage to the right arm of the chair revealed more fire damage on the outside of the chair closest to the bed than elsewhere. Protected areas on the gypsum wallboard were visible behind the chair and nearer to the nightstand.

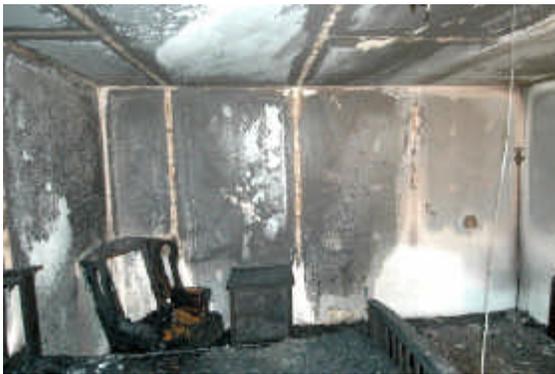
Figure 4. View to W in cell 1 showing areas of clean-burn on south and west walls

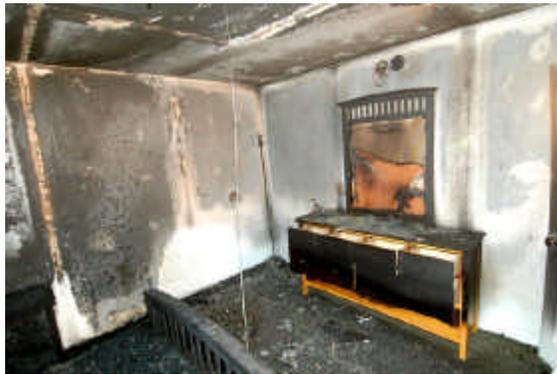
Figure 5. View to NW corner of cell 1. Note lesser damage towards the north end

At the north end of the west wall, almost no damage had occurred to the wallboard near floor level. On the wall above the nightstand was what appeared to be the start of an area of clean burn. Elsewhere on the wall, smoke staining was worse towards the south end of the room.

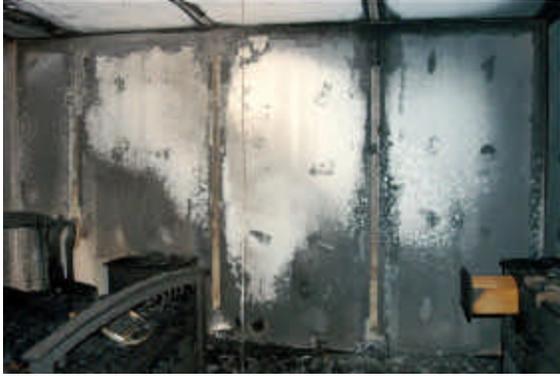
Post-fire examination revealed clear evidence of fully involved, post-flashover fire conditions. The walls were badly smoke stained to floor level. Two glaring burn patterns were immediately obvious upon entering the compartment. First, a large “V-pattern” of clean burn was visible on the west wall and centered just north of the nightstand. The apex of the pattern was about 15 inches above the floor. The lower portion of the “V” had nearly vertical sides about a foot high above which the sides of the “V” spread outward. On the ceiling above the “V” was a wide area of extensive damage where the wallboard had badly cracked and nearly failed.

Figure 6. View to W wall of cell 3 showing a large, clean-burn “V-pattern”

The “V-patterns” on the west walls of cells 2 and 3 were remarkably similar yet clearly bore no relationship to either of the fires’ origins which were approximately six feet from the apex of each “V”. No fuels other than carpeting had been below the patterns prior to the fire. The west wall of cell 1 showed an area of clean-burned, wallboard damage in the same general location as the upper left portions of the clean-burned “V”s in cells 2 and 3. Had test 1 been allowed to burn longer, it is likely that the existing small area of clean burn would have grown to become more like those areas in the other cells.

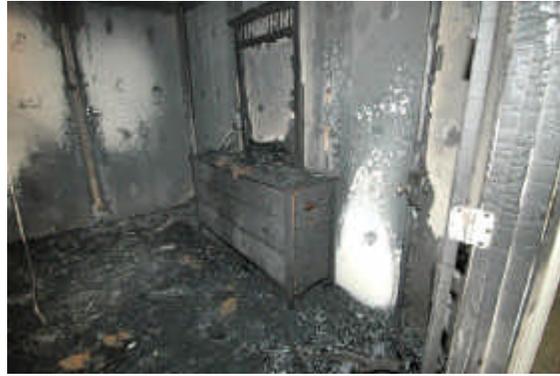
Figure 7. View of N wall of cell 3 through the doorway. Note the area of clean-burn.

The second area of extensive clean-burn was located on the north wall between the dresser and the open door. It extended from floor level up about three feet (to near the top of the dresser) and formed a pattern similar to an “inverted-V”. The end of the dresser next to the pattern, though charred was intact. The frame of the door east of the pattern was also badly charred but intact. The center web or panel of the door had burned away. The wall above the clean burn was smoke stained and less badly damaged than the area below it. The ceiling directly above the clean burned area showed no indications of circular patterns as might be expected from plume impact.

The clean burn in test 3 between the door and the dresser is due to the efficient mixing of unburned fuel gases and swirling air currents from incoming airflow. In the test video, swirling eddies of low level, incoming air are clearly visible at the north side of the doorway. This turbulent flow enabled efficient mixing of available oxygen with fuel gases in the area. The reason such damage did not occur in test 2 is probably because the concrete block at the base of the door interrupted the eddy formation. Had the clean-burn damage along the dresser in cell 3 been caused by a fire origin, one would have expected to see plume-related patterns at the upper reaches of the wall above the pattern and on the ceiling where plume would have impacted.

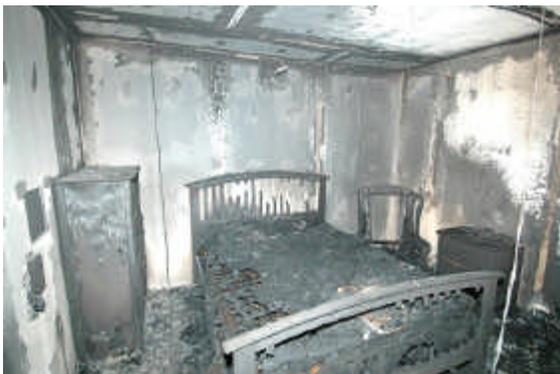
Damage to the mattress was uneven. Next to the area of origin, the fabric had mostly burned away. Similar damage occurred on the east side of the mattress close to the open doorway. The damage near the doorway was more extensive than that nearer the origin.

Figure 8. View to SW in cell 3 showing damage to the bed’s east side near the door

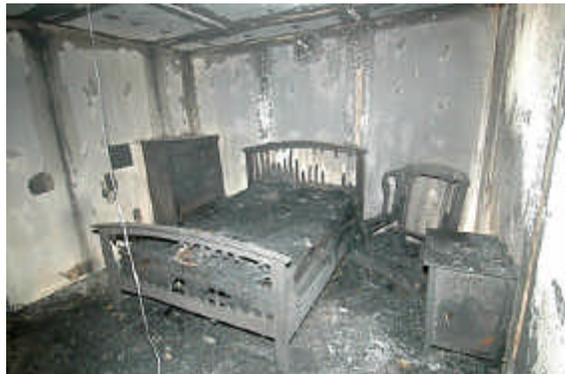
The fire did not cause an area of clean burn on the south wall near the origin as had occurred in cell 1. Since the fires were started in the same manner, participants expected to find a similar clean-burn from early flame contact. The wooden slats making up the headboard had, as in cell 1, burned in a “V” which appeared to be caused by flames or hot gases spreading out from between the bed and the chair. Damage to the wooden frame of the upholstered chair was slightly greater on the east side. Similarly, damage to the bed frame was most extensive near the area of origin. Without more information, the bed and chair burn patterns could have been attributed to the close proximity of burning fuels.

Figure 9. View to SE in cell 3. Note the absence of clean-burn near the origin

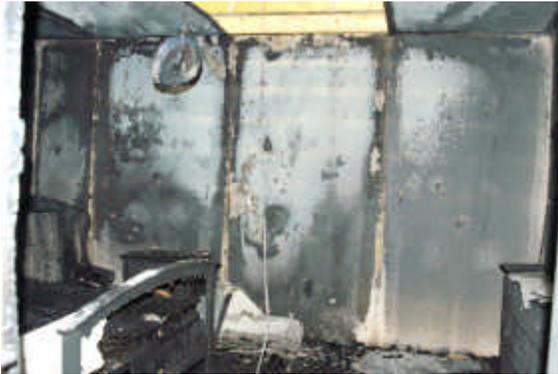
Because of the irregularities experienced in test fire 2, participants examined cell 2 last. Upon entry, a large clean-burn “V-pattern” was clearly visible on the west wall. The pattern was very similar in shape and location to a corresponding pattern in cell 3. The apex of the “V” in cell 2 was about 14 inches above the floor and north of the nightstand with almost the same location, shape and size as the pattern in cell 3. As in cell 3, the bottom section of the clean-burn had near vertical sides that further up, spread outward.

Figure 10. View to W in cell 2 showing the clean-burn “V” similar to cell 3

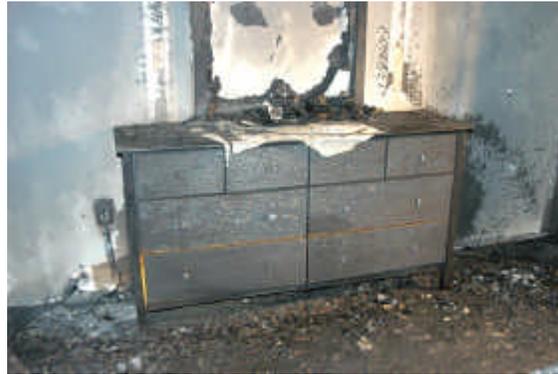
Figure 11. View to N in cell 2. Note the lack of clean burn to the right of the dresser

No remarkable fire patterns were visible on the north or east walls of the cell. The doorframe of cell 2 had mostly burned away unlike in cell 3. No area of clean burn was visible between the edge of the door and the dresser. The concrete block used to prop the door open during the test likely protected the area behind it from extensive burning.

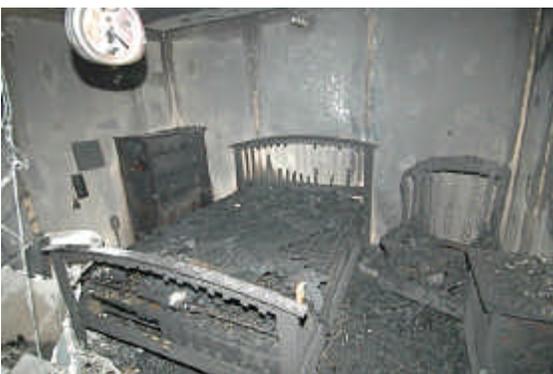
As in cell 3, there was no clearly visible, clean-burn pattern in cell 2 on the south wall near the fire origin. Close examination of the area revealed light cracks in the surface of the wallboard where flames contacted the wall, however no obvious surface discoloration was visible. Consistent with cells 1 and 3, the headboard in cell 2 showed indications of a “V-pattern” extending upwards from between the bed and the chair. Visible damage to the wall between the mattress and the chair was generally unremarkable.

Figure 12. View to S in cell 2. Note the lack of clean burn near the origin

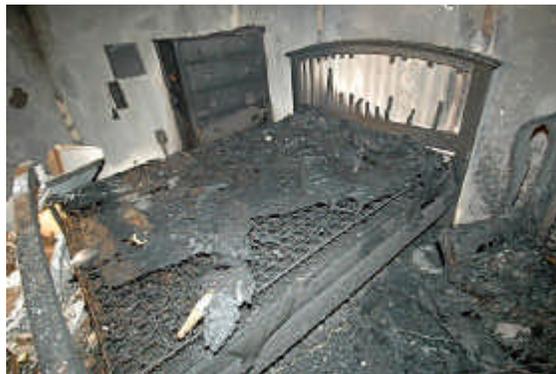
Figure 13. View to SE in cell 2. Note more severe mattress damage than in tests 1 & 3

The bed frame next to the origin was the most badly damaged section. As with cell 3, the damage could, without additional information, be attributed to the upholstered chair burning mere inches away. Overall, mattress damage was the greatest in test 2, probably because the second fire burned longer than had the others.
