“CLEAN BURN” FIRE PATTERNS – A NEW PERSPECTIVE FOR INTERPRETATION

Steven W. Carman, IAAI-CFI, ATF-CFI (Retired)
Carman & Associates Fire Investigations, Dunsmuir, CA

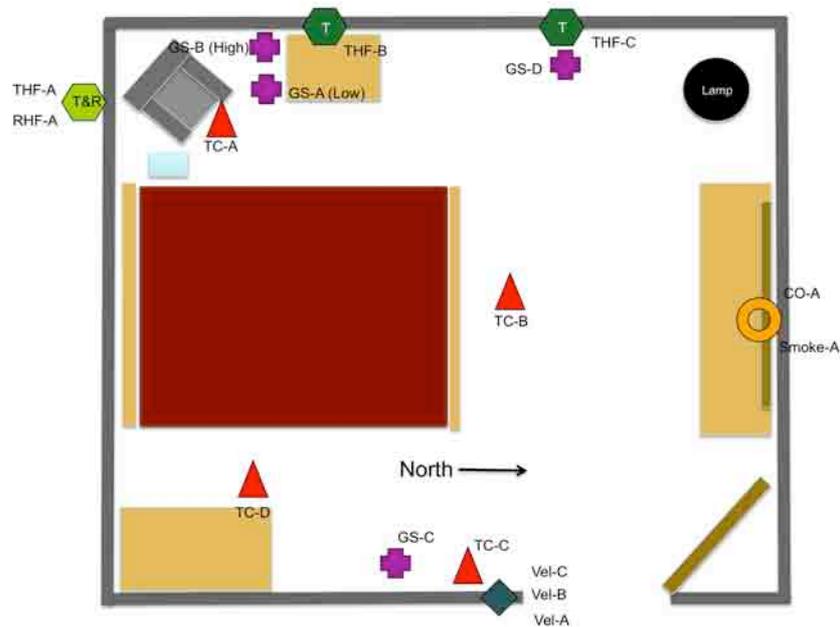
Figure 1. Layout of FRL burn cells showing instrumentation

Calorimetry data was not monitored during the tests. A diagram of the cells is shown in Figure 1.

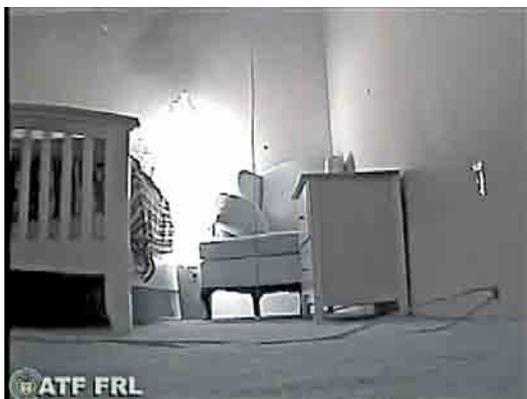
Fig 8 - Test 2 shortly after ignition

The three cells were examined in the order they were burned. Since each of the fires was started in the same fashion, investigators expected to find similar fire patterns near the origins. It was thought that the extent of damage might differ due to longer burn times in Tests 2 and 3. The findings were surprising. Neither Cells 2 nor 3 had any clean burn patterns near the origin as seen in Figures 6 and 7. This was despite video showing similar early flame contact with the nearby walls in each of those tests like occurred in Test 1. Photos of the flames impacting the walls are shown in Figures 8 through 11.

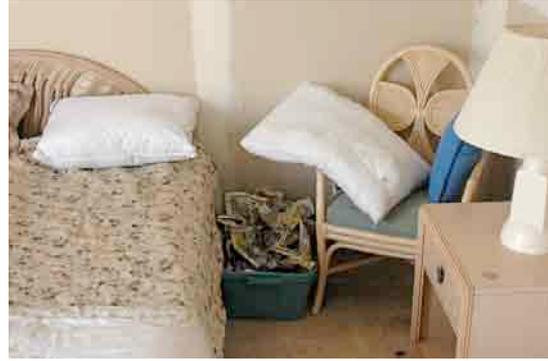
Fig 13 – Las Vegas cell before fire

Figure 12 shows a clean burn pattern found near the fire origin in one of the Las Vegas fire tests. That fire burned for 3-1/2 minutes post-flashover. Some might argue this shows that extended burning will not eliminate clean burn patterns since the Las Vegas fire burned longer than either FRL Test 2 or 3. A major difference in the tests is that in the Las Vegas, there was less soot-producing fuel near the clean burn pattern. The wicker chair used in Las Vegas had a small, upholstered cushion shown in Figure 13. In each of the FRL tests, the wicker chair was replaced with a larger, upholstered chair. Those chairs had much more polyurethane foam that would have continued to pyrolyze and release soot into the room after the wicker chair would have mostly burned away. This extra foam could have produced the nearby soot layer coating the wall adjacent to the fires’ origins.
